Inspection Report

| Permit Number: | C0070012 |
| Inspection Date: | Thursday, April 28, 2005 |

Site: **WELLINGTON PREPARATION PLANT**

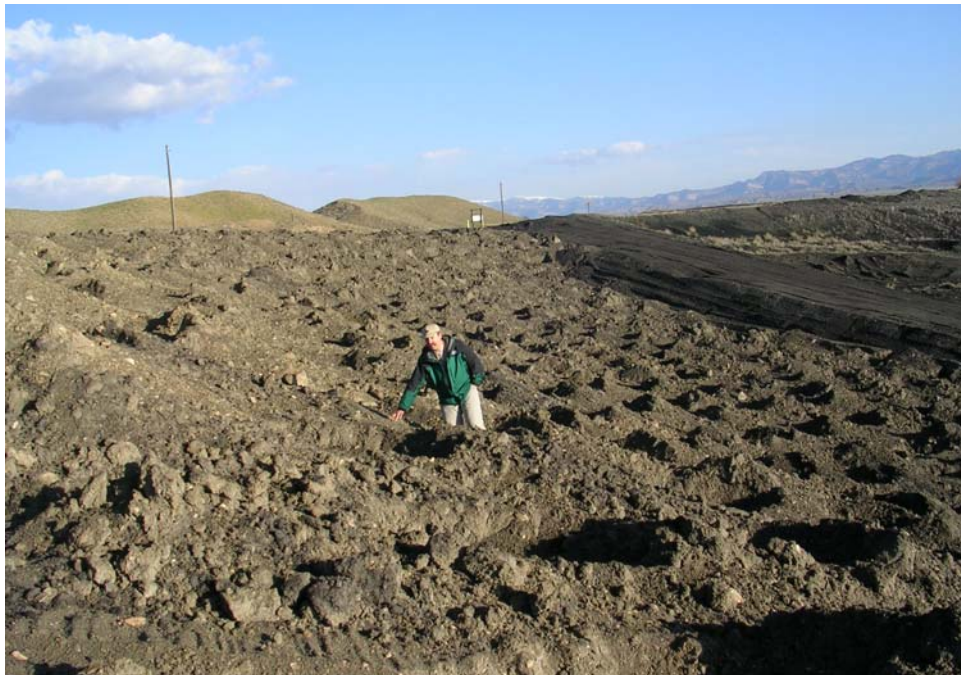
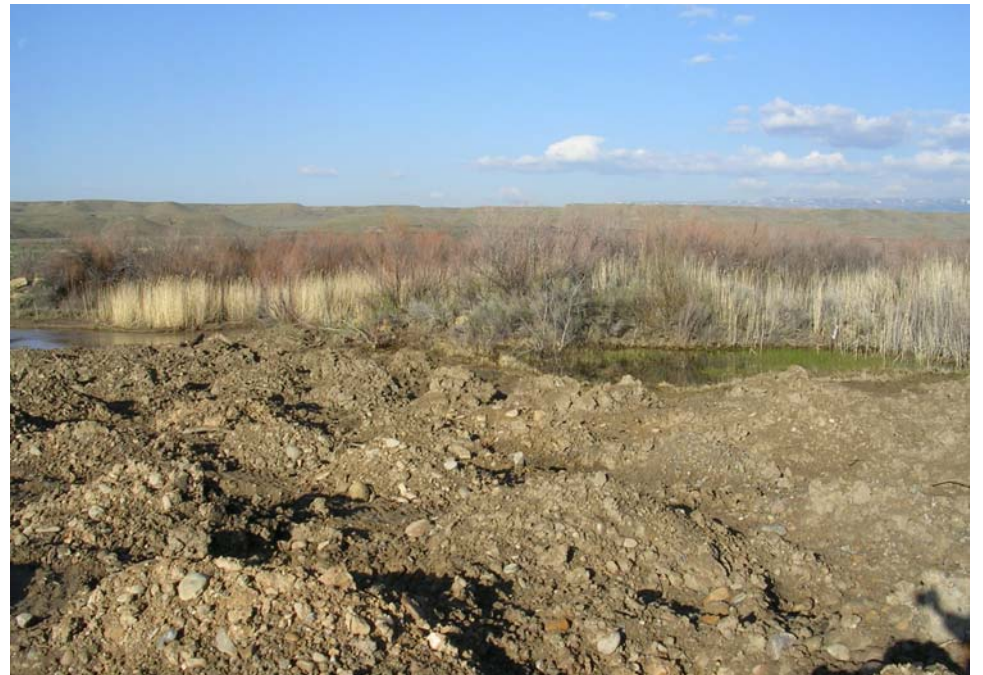
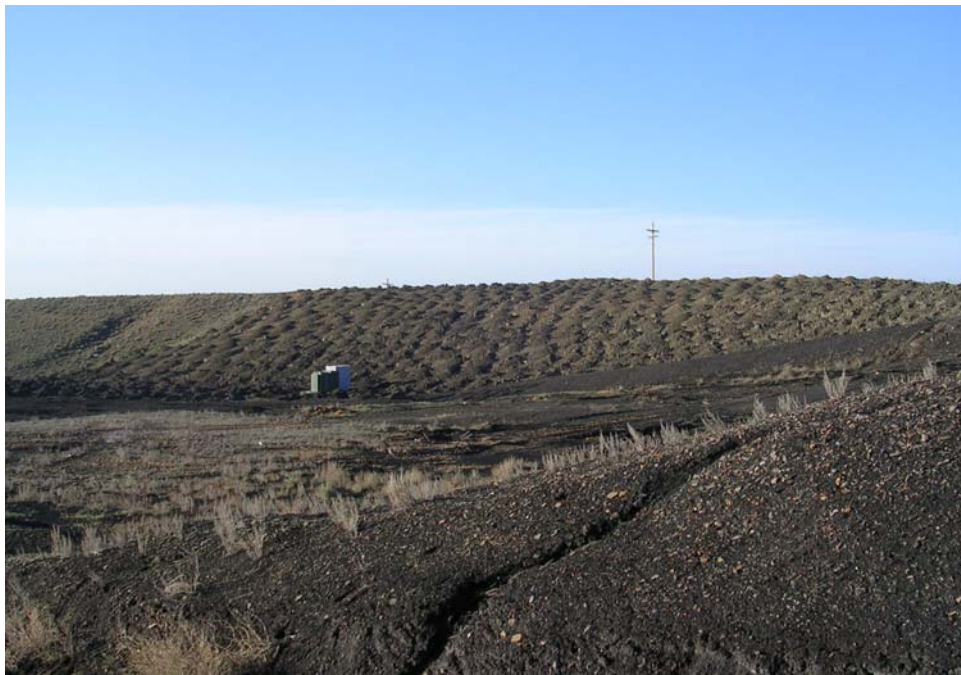
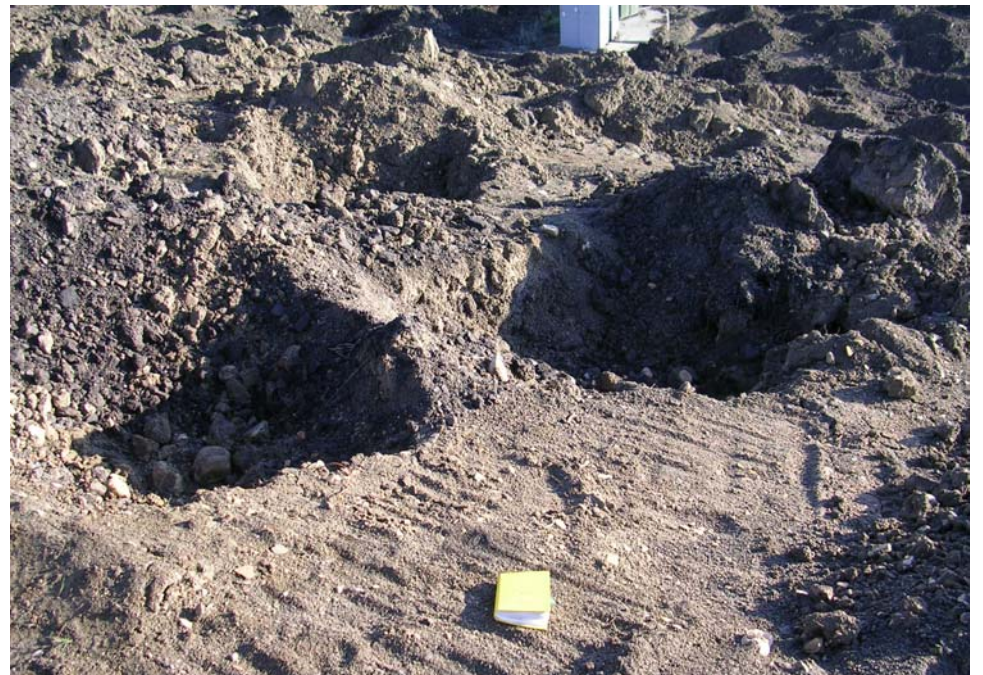
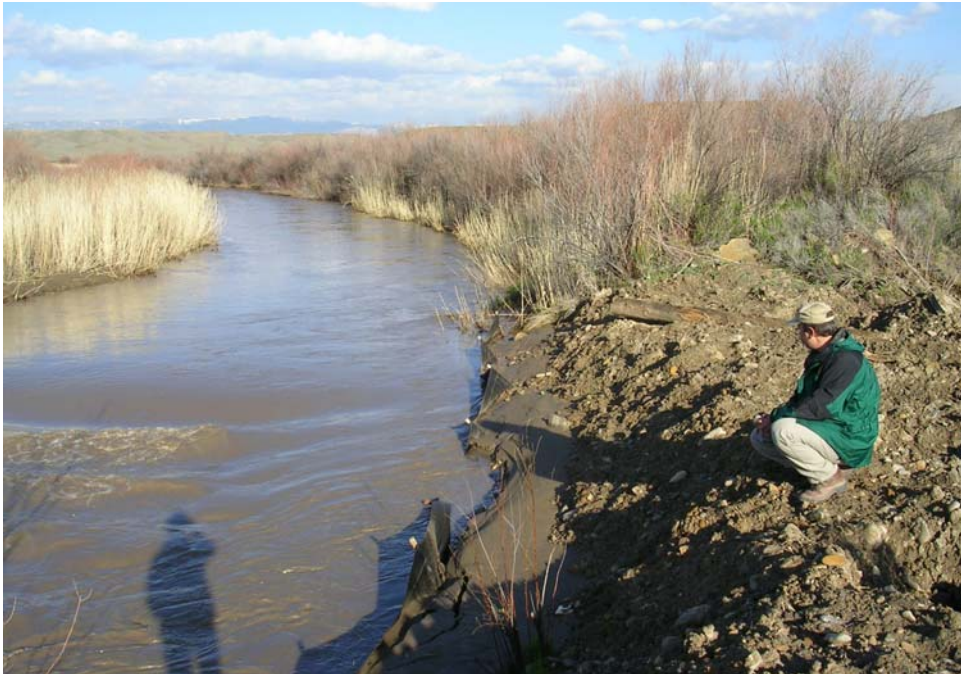
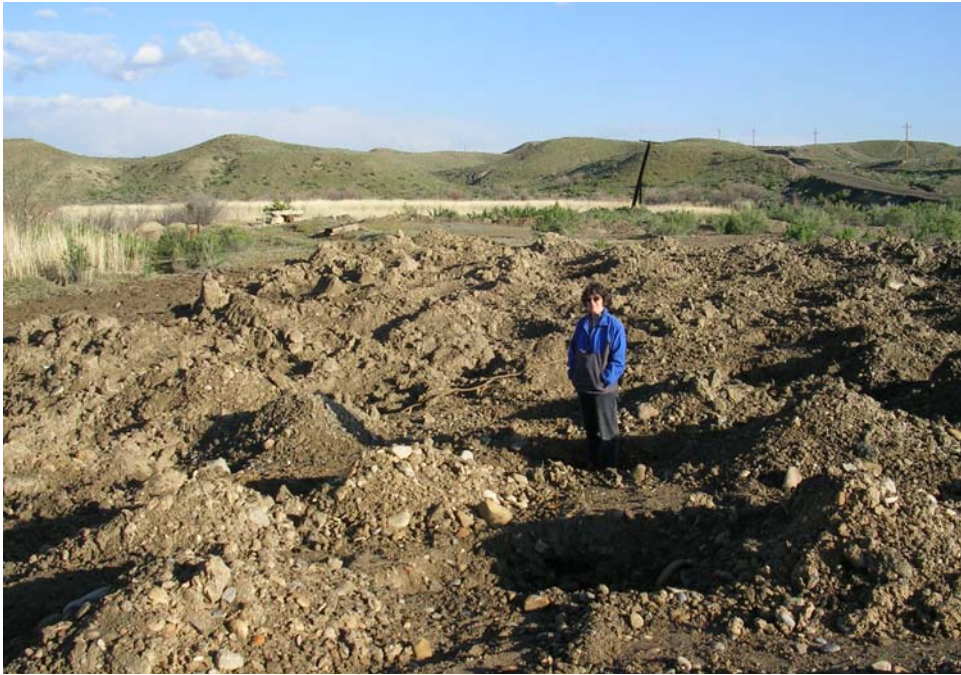
During the first week of April, Rocky Mountain Excavation was hired to gouge and seed the graded slope at the COVOL operations site (near the slurry ponds) and the river pumphouse site. Gouges were placed such that a bit of slope above the gouges would harvest water for the gouge. Larger seed (such as A. gardneri) was visible on the surface. Rains the previous night probably buried the smaller seeds just under the surface. (See Dwg F9-177 sheet 2 of 2 for locations). Seed mix for each site was different. The riparian area near the pumphouse had Distychlis (saltgrass). Mr. Collins will provide the Division with a copy of the seed mixes.

Price River was swollen with rain from the previous night. The river had overtopped the silt fence at the pumphouse reclamation site. The river was obscuring the view of the cement damn at the pumphouse. When the river level subsides the silt fence will be repaired.
